# Study of stress and temperature measured in the president costa e silva bridge (steel structure), M.S. thesis, May 1976.

A THESIS  
PRESENTED TO THE GRADUATE COMMITTEE  
OF LEHIGH UNIVERSITY  
IN CANDIDACY FOR THE DEGREE OF  
MASTER OF SCIENCE  
IN  
CIVIL ENGINEERING

May 1976

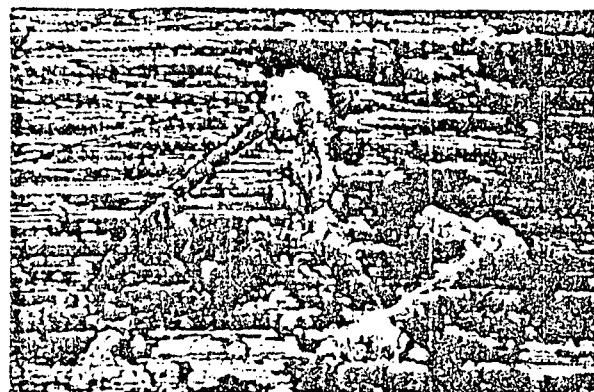
Fig. 11 SCRATCH GAGE TRACES (90X) - CONSTRUCTION STRESS CHANGES

FB27 TOP

FB 42 TOP

FB 27 BOTT

FB42 BOTT
